GISTM Public Disclosure Report

Chapada Mine Chapada Tailings Storage Facility

October 2023

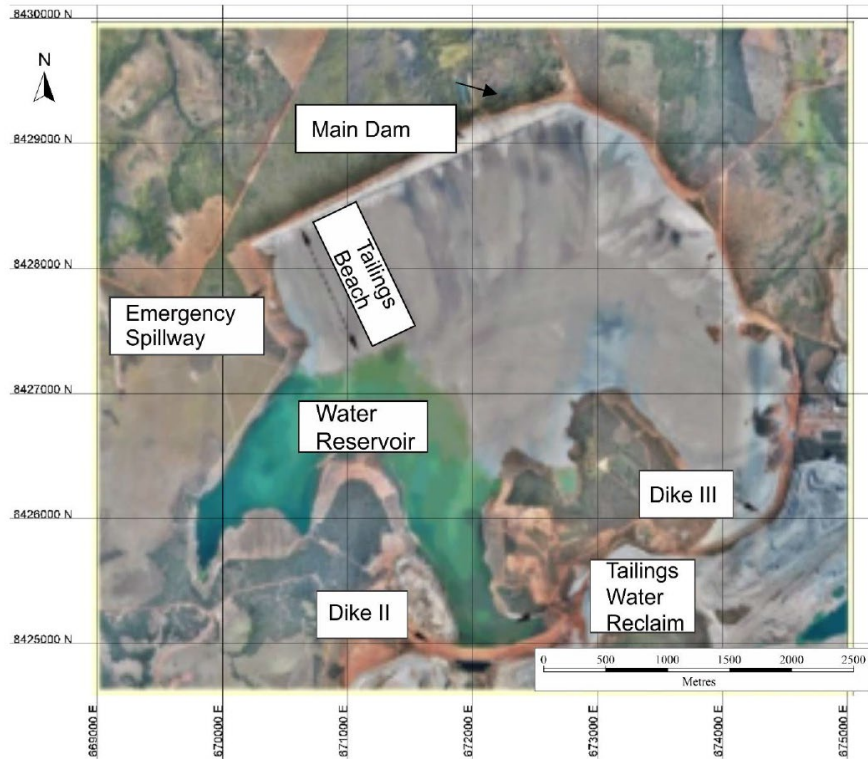
Figure 1: Chapada Tailings Storage Facility Layout

The Chapada TSF is designed to store both tailings and industrial water. The Chapada TSF occupies a total area of approximately 1,400 hectares or 14 km². The impoundment, also known as Barragem de Rejeitos do Córrego Baco Pari is comprised of natural topography to the west and three containment structures: the Main Dam , Dike II, and Dike III.

In order to confine the impoundment on the southern side of the facility, two small saddle dams have been constructed: Dike II and Dike III. Dike II located north of the South pit, is a lined, downstream constructed dam, consisting of compacted residual, clay-like soil. Dike II retains the supernatant pond at the south end of the TSF and does not retain any tailings. The drainage system of Dike II consists of a chimney filter and a blanket drain.

Dike III located northwest of the Central pit, is a centerline constructed dam with compacted cyclone tailings using the coarse tailings fraction (cyclone underflow) for construction. The fine fraction (cyclone overflow) is deposited as slurry and impounded within the TSF.
